Overview of recent DiMES experiments

Dmitry Rudakov (UCSD)
for the DiMES Team

Outline

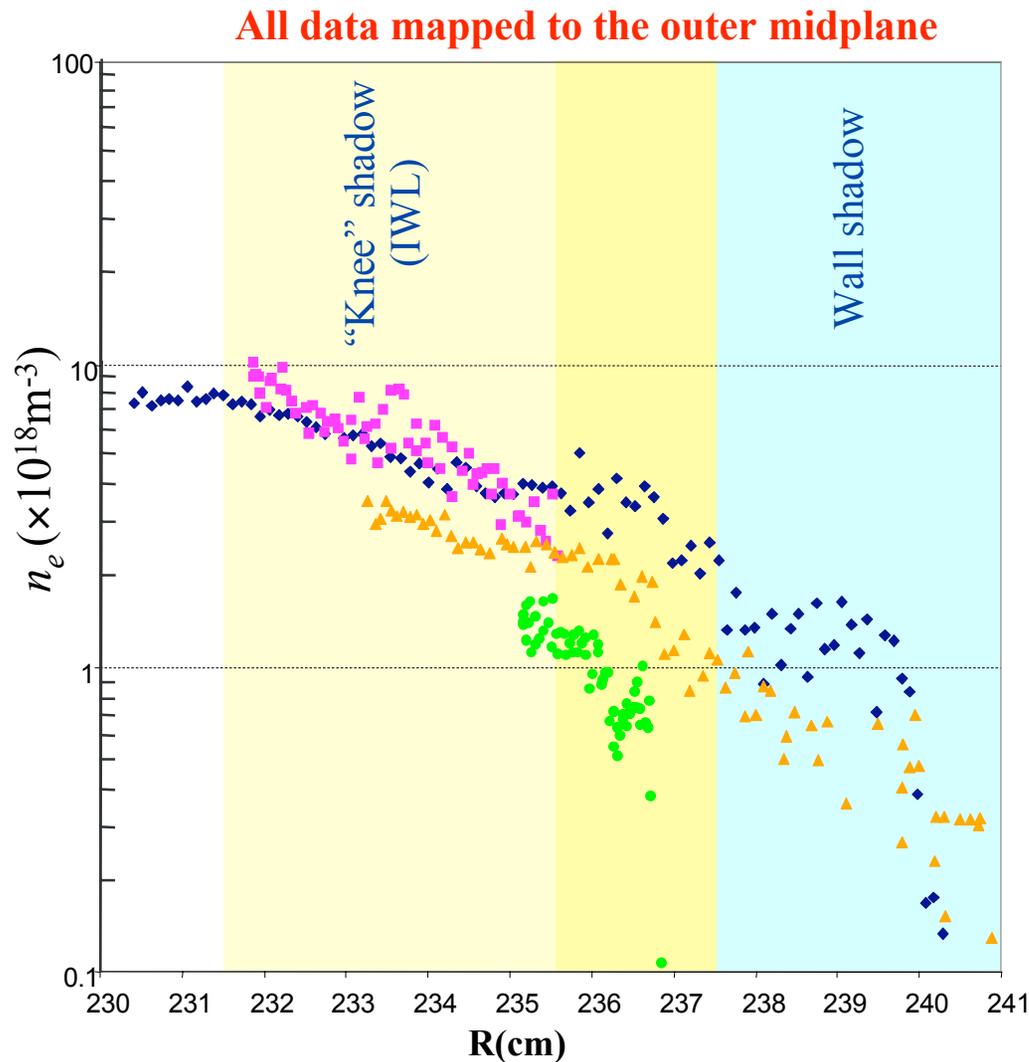
Lower divertor plasma conditions in IWL and USN are comparable to those near the outer wall

Shot 107577

IWL configuration L-mode

Shot 114849

USN configuration L-mode

Lower density in USN is probably due to the secondary X-point

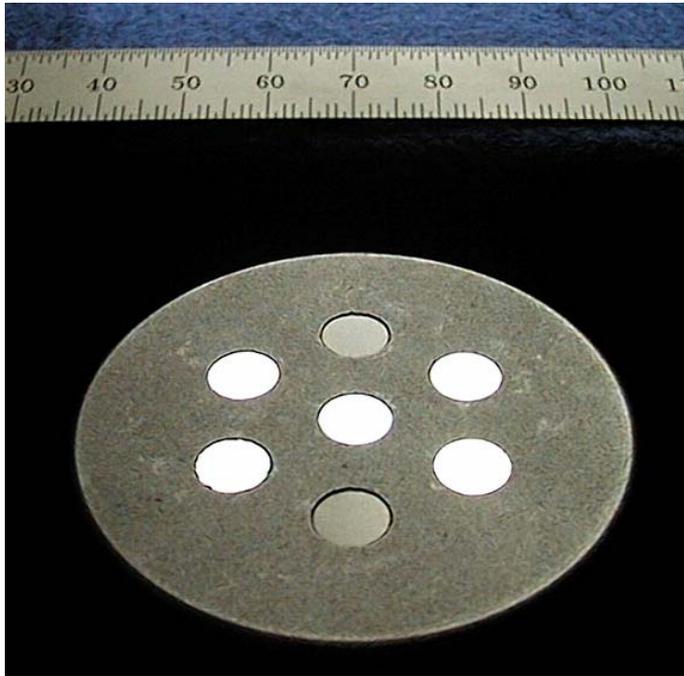
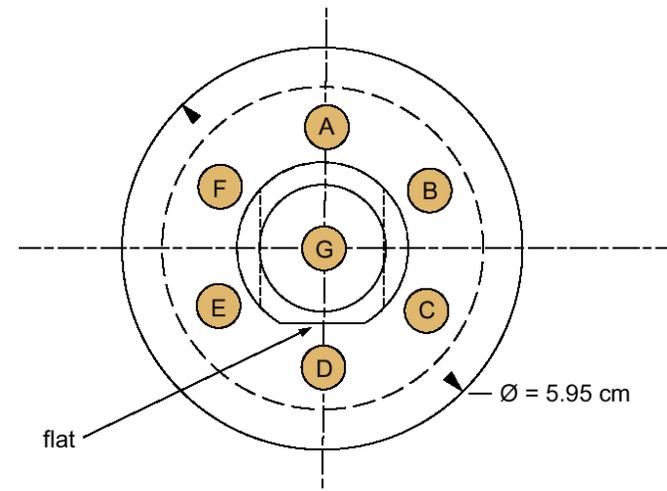
DiMES #107 multi-sample probe

- DIMES #107 has been exposed to a series of 22 plasma discharges
- 20 of the discharges were USN, 2 IWL
- Most of the discharges were L-mode (there were a few spontaneous transitions to ELMing H-mode)
- All discharges had comparatively low density

A	53a C Si marker
B	R5C4 Be on Si
C	Witness 74 Be on Si
D	53b C Si marker
E	V on Si
F	W on Si
G	C1 C on Ti/Si

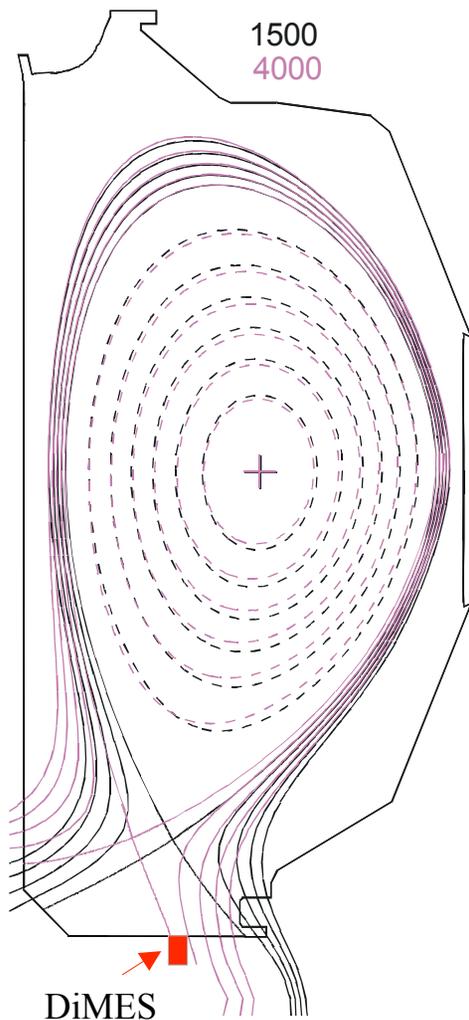
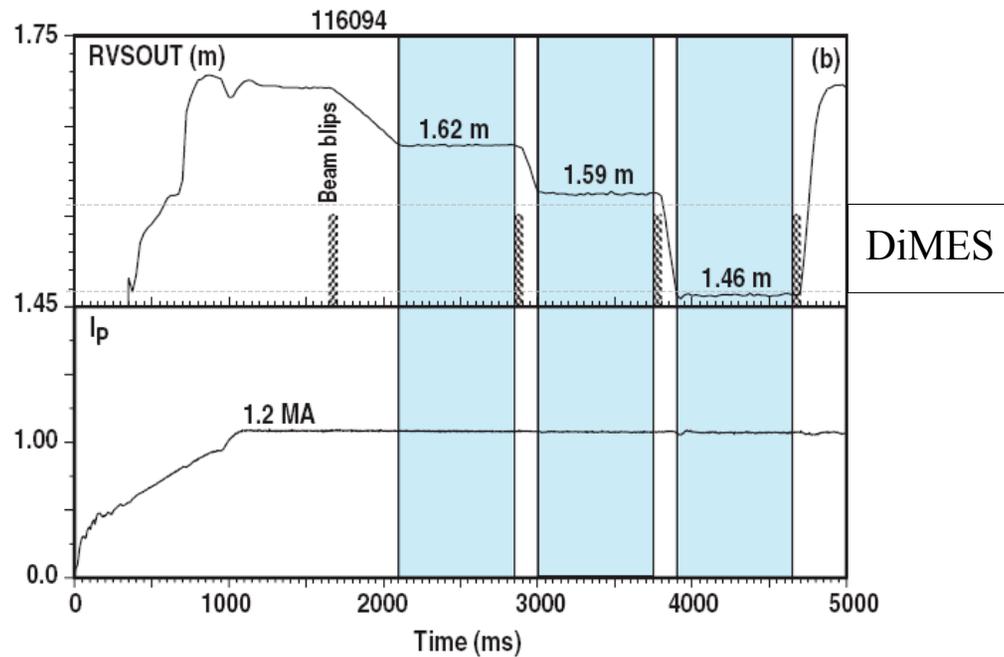
He SAPP experiment

- The line-averaged core density was changed, shot to shot, to give the five values $1.4, 2.4, 3.5, 4.5,$ and $6.8 \cdot 10^{13} \text{ cm}^{-3}$
- Within each shot, the OSP was moved in stepwise fashion to dwell positions at successively smaller major radius
- The innermost OSP dwell position was at the inboard edge of the DiMES sample
- The sample was exposed to 13 discharges with the total exposure time of about 10 s

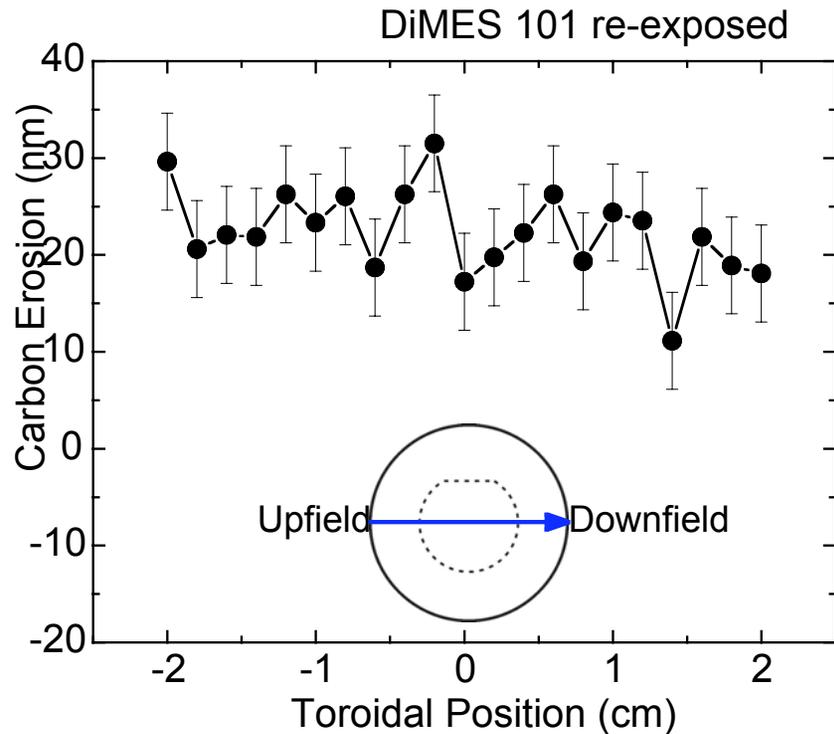
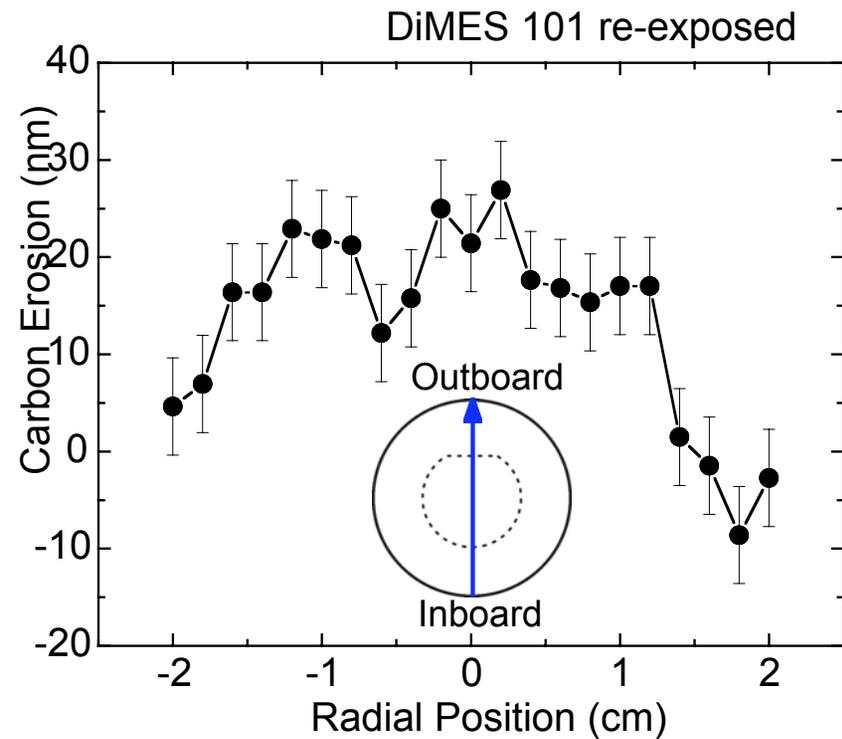
Analysis results from Bill Wampler

**The total net measured erosion is about 25 nm,
making an average rate of 2.5 nm/s**

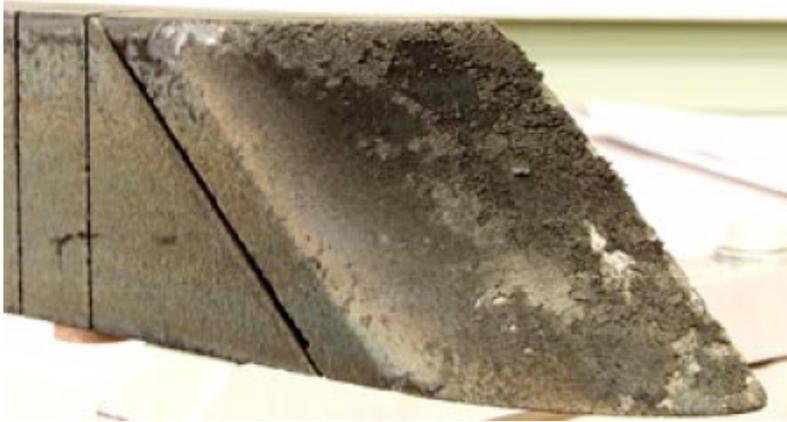
Tore Supra Neutralizer:

Thick deposited layer - 150 μm after 2h20m of plasma; (= 1day of ITER ops.),
High growth rate (20 nms^{-1})

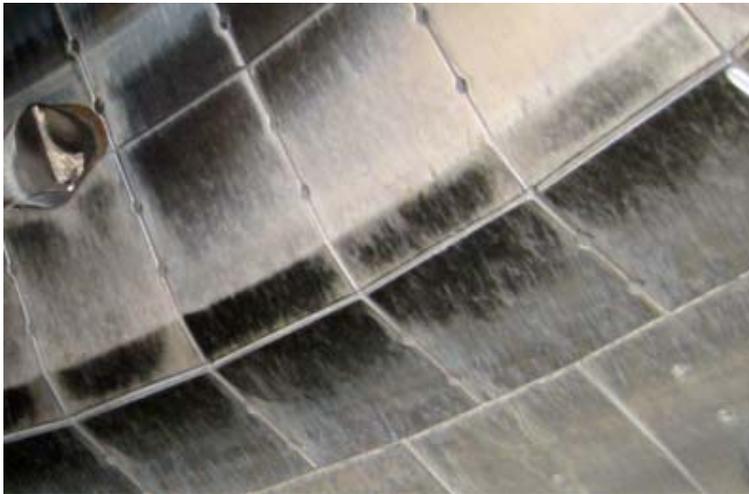
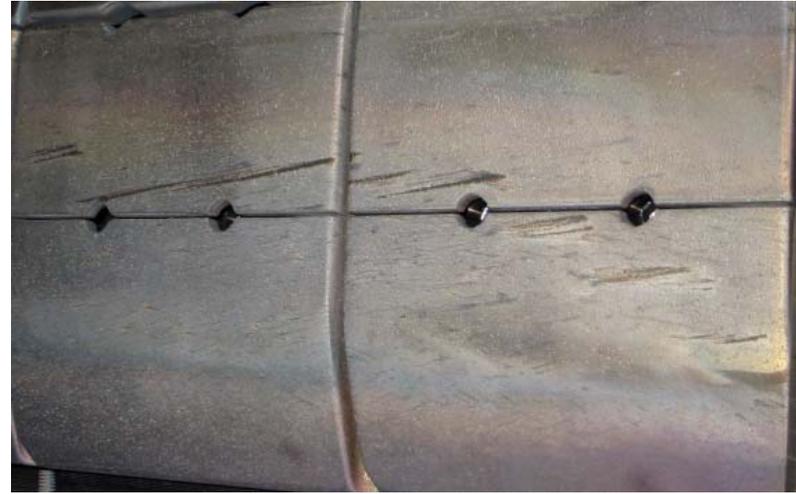
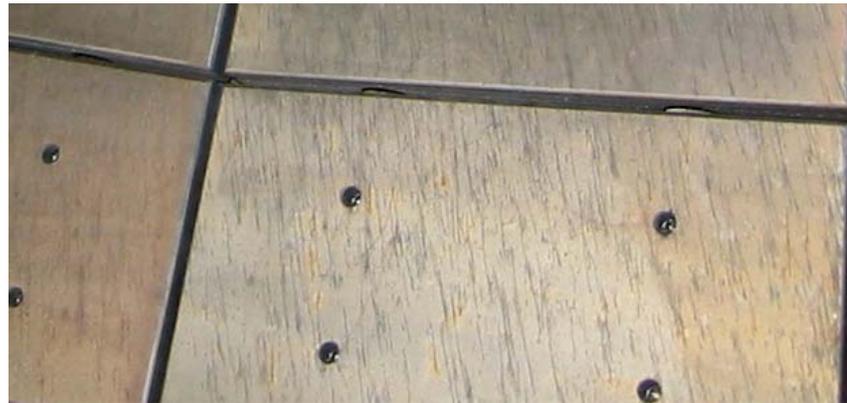
- In DIII-D dust is commonly found during vents in ports, between tiles etc.
- Many of DIII-D tiles feature scratch-like marks, supposedly due to arcs

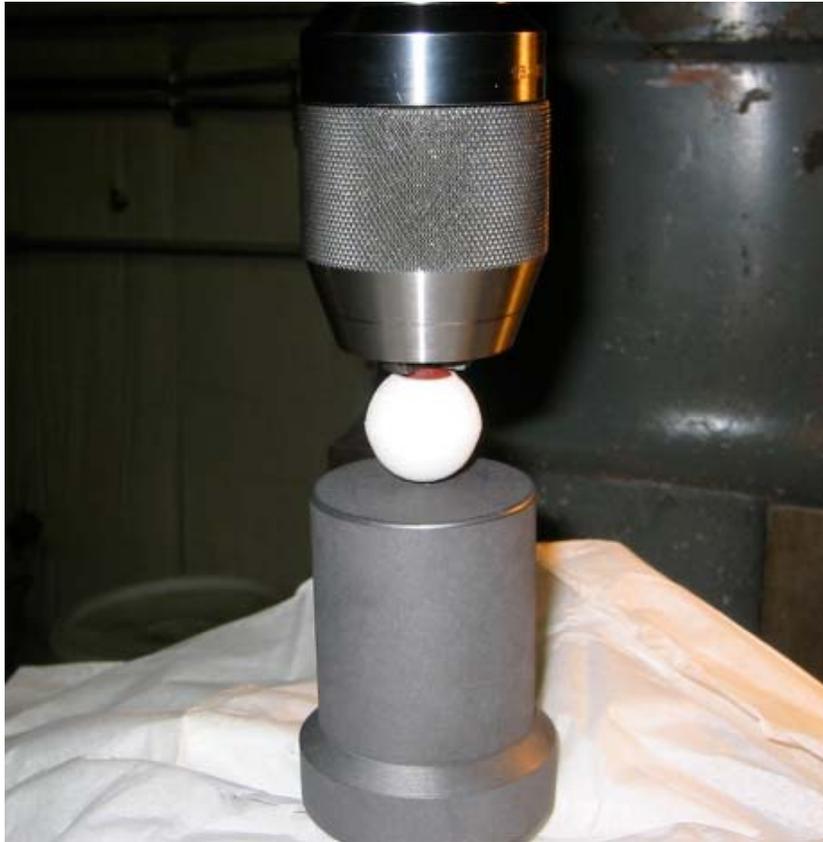
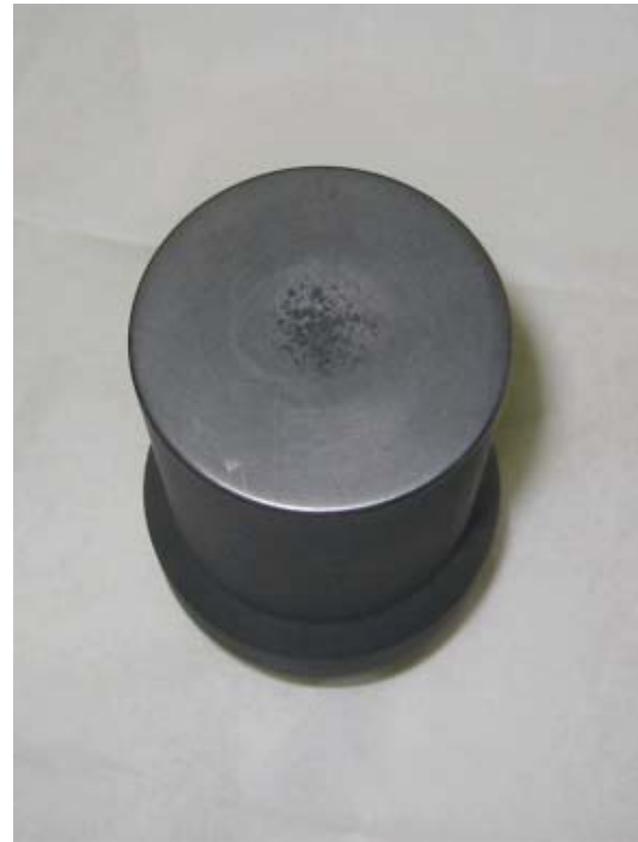
Dust DiMES sample: modified sample #91

A small dip (~ 0.7 mm deep and about size of a dime) was machined in the middle of the sample surface and then polished by fine sanding paper

A small amount of graphite dust scraped off the side of an old DiMES plug was placed in the dip

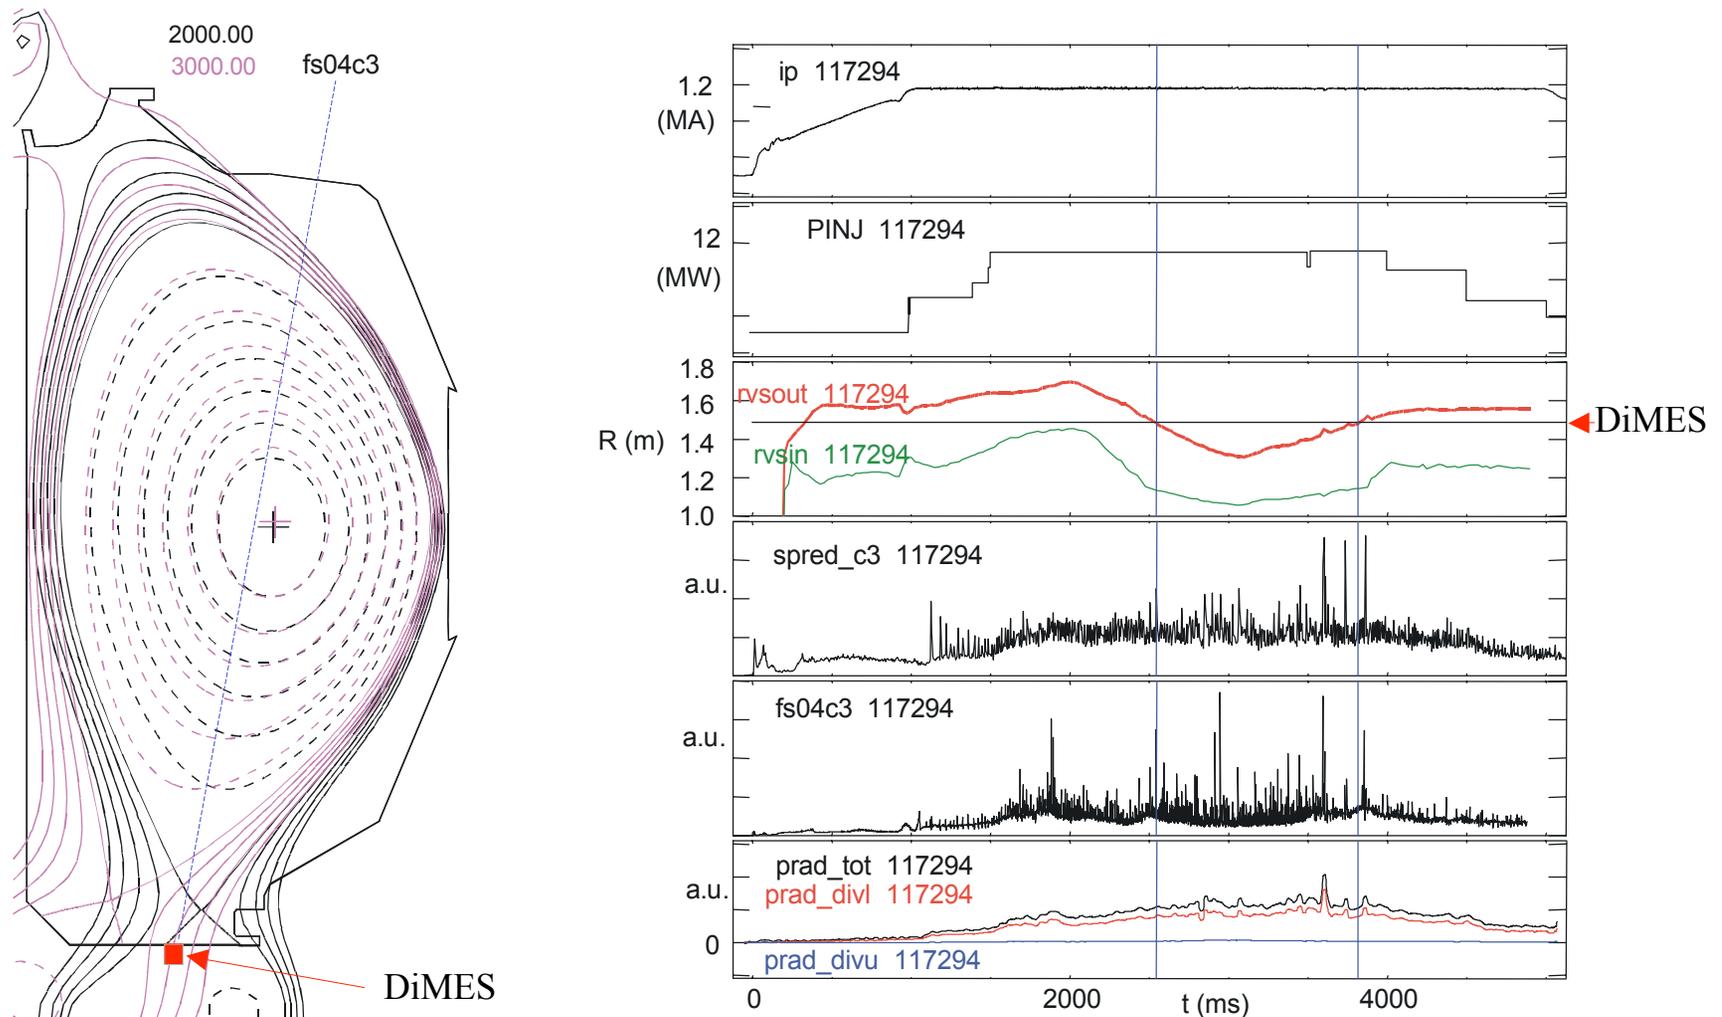
Sample exposed to two high-power LSN shots wit OSP sweep

- OSP was swept across the sample twice, around 2.6 and 3.8 s
- ISP dwells near the sample for about 200 ms around 2.0 s
- No visible increase in carbon light from either core or divertor

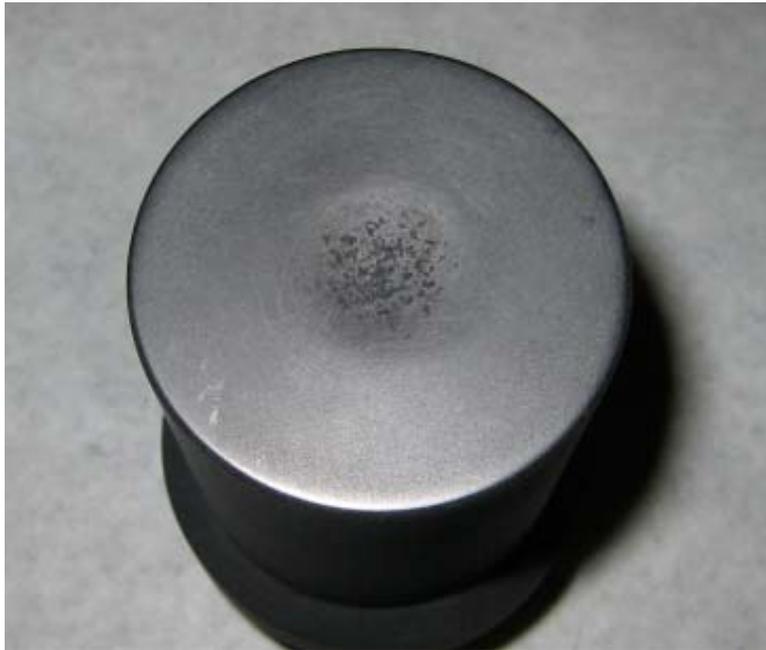
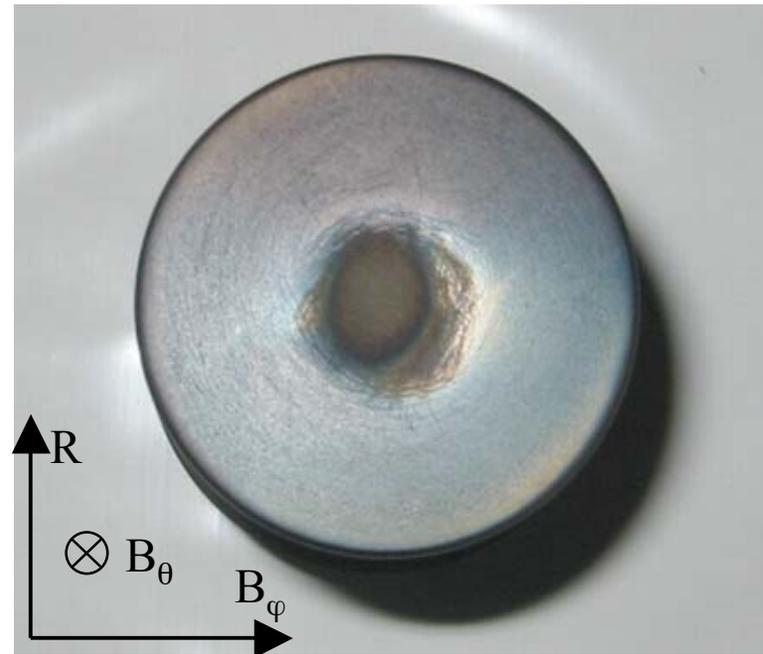
Dust DiMES sample before and after exposure

- There was no loose dust on the sample surface upon removal
- An oval gray area appeared on the left side of the dip
- This area was shaded from the direct plasma contact along the field lines during the exposure to OSP

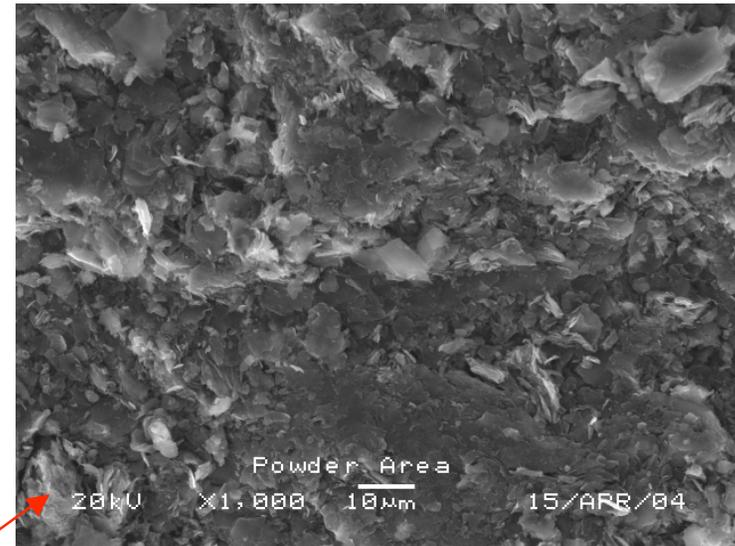
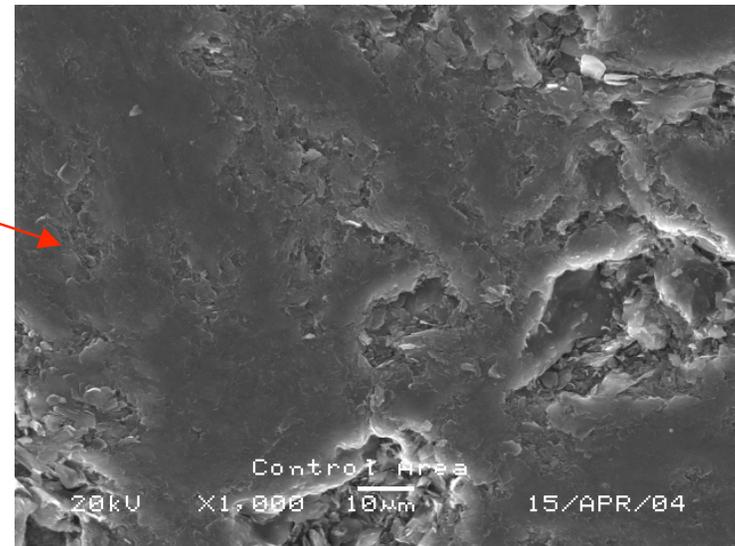
Inside the gray area

It looks like at least some of the dust got re-deposited in the shaded part of the dip
